## EXPLORING THE IMPACT OF WATER LEVEL VARIATIONS ON MODEL RIVER BANKS COMPOSED OF DIFFERENT SOIL TYPES A FLUME-BASED INVESTIGATION

Research Article – Available at <http://larhyss.net/ojs/index.php/larhyss/index>  
Received October 12, 2024, Received in revised form May 28, 2025, Accepted June 1, 2025

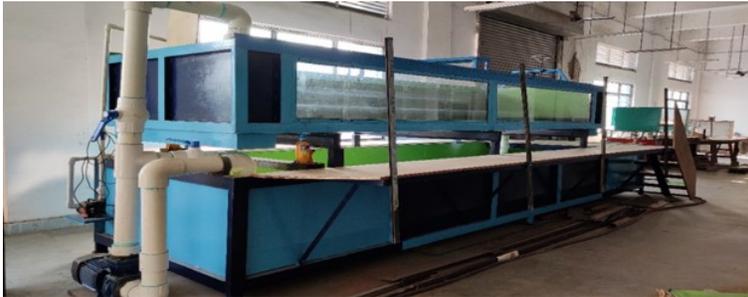
The model flume's measurements are roughly 550 cm long, 150 cm wide, and 60 cm deep. An adjacent seepage area is incorporated into this experimental flume along the bank's longitudinal sides. Two sets of pumps have been added in the setup to make testing for filling water. The seepage tank's water level is kept constant by a 5L/s pump, which replicates the water table inside the bank. Concurrently, a 32 liters per second pump is utilized to produce channel flow for filling the water in model flume. Trial experiments were conducted to assess the pump capacity with great care to achieve drawdown ratios from the high flood level, which is necessary to observe failure circumstances. Interestingly, the setup's arrangement is intended to closely resemble real-world situations. The images of real setup of experimental model flume were shown in Fig. 1a.

**Figure 1: Picture of the model flume (a) Photographs of flume (b) Photographic and schematic view of pore pressure device and location for pore water pressure measurement**

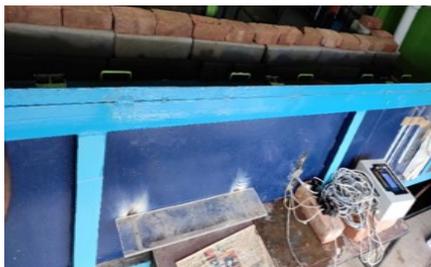
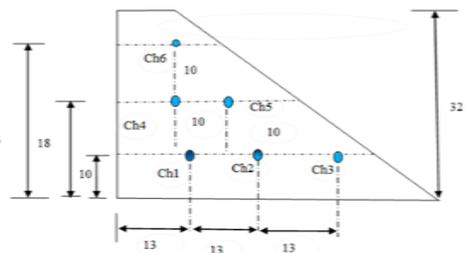
(b)

The variations in pore water pressure along the cross section of the model river bank were measured using a Pore water pressure monitoring system with Sensors and Data-logger shown in Fig. 1b. Six channel of pore pressure measuring device placed at different locations on the bank during the construction of the model river bank. The other ends of these tubes are connected to the sensors for measuring the pressure. The working range of these pore pressure devices laying between 0.01 kPa to 4 kPa. The positions of these sensors pipe within the bank are illustrated in Fig. 1b.

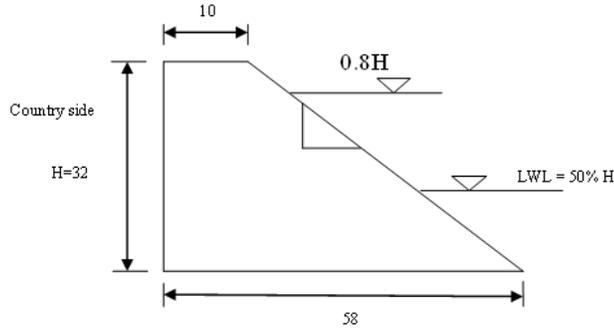
**Figure 2: Bank Geometry (Dimensions in cm according to Table 1)**

The experiments were carried out to investigate the effects of different drawdown ratios and bank materials on the failure mechanism and profile of a river bank. For each series, a physical model was created in a lab flume with the same bank height and a constant 1V:1.5H slope. Table 1 provides specifics on the model bank geometry's dimensions, while Fig. 2 provides illustrations of the bank geometries and slopes.

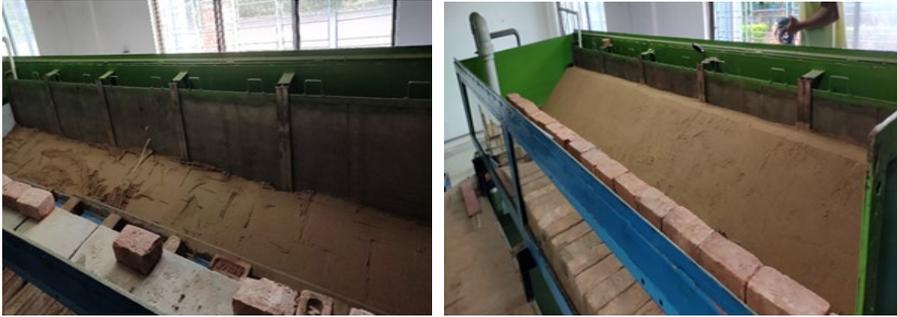
**Figure 3: Model Bank prepared in flume**

A precise methodology was utilized for both series-I and series-II in order to guarantee the specified attributes of the model embankments. Non-cohesive model embankments were intricately constructed in series-I using a consistent compaction. The primary bulk densities, adjusted according to water content (WC) percentages of 13 and 6 were an immediate outcome of this procedure. Achieving the desired density necessitated the systematic construction of the banks in three tiers, each subjected to 25 impacts. Series-II focused on model banks composed of silty dominated clay soil having 10% and 15% moisture for achieving the target unit weight of  $17.6 \text{ kN/m}^3$  and  $18.56 \text{ kN/m}^3$ . Throughout the preparation procedure, each layer received a compaction energy of  $0.209 \text{ kg/cm}^2$ , guaranteeing accuracy and uniformity in the model's creation (Fig 3). Both series meticulous preparation techniques sought to provide realistic riverbank models that would enable a thorough examination of the impact of different variables on the failure of bank.

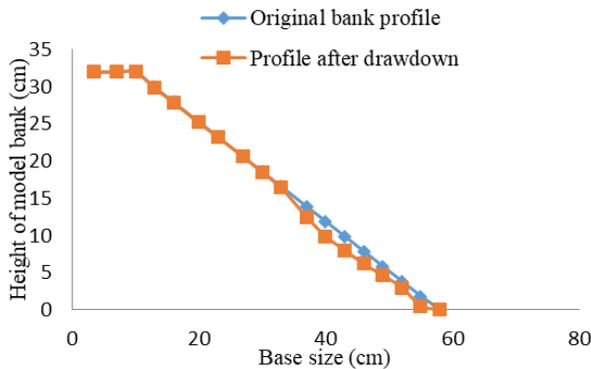
Figure 4: Profile of bank for water content 6% and water level 50%

Twelve model experiments were carefully carried out in this experimental series for a bank prepared with cohesionless soil, for drawdown ratios of 0.5 and 0.8 of the height. The starting water content of 6% and 13% were purposefully chosen to provide some variation in the properties of the soil. The different profiles for different cases are shown in Figs. 4,5,6 and 7. The model riverbank failed very little near its toe for 0.5 times height and moisture content of 6%.

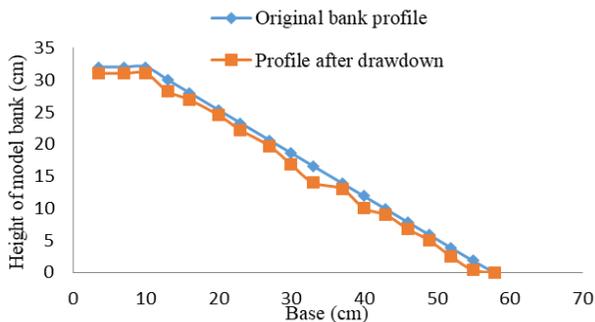
Figure 5: Profile of bank for water content 6% and water level 80%

On the contrary, the depletion of 0.8 of height led to a notable failure, resulting in the sliding of the soil mass at the center of the slope. It is noteworthy that, unlike the 0.5 time of height reductions, the 0.8 time of height reduction with a moisture level of 6% triggered the most prominent failure, irrespective of water content. This observation points to a greater susceptibility to failure in situations with more severe drawdown. It's noteworthy to notice that the slight increase in moisture content from 6% to 13% had no appreciable impact on the size of failures, regardless of whether drawdown was at 0.5H or 0.8H. This research's output sheds light on the intricate relationships that impact the stability of bank.

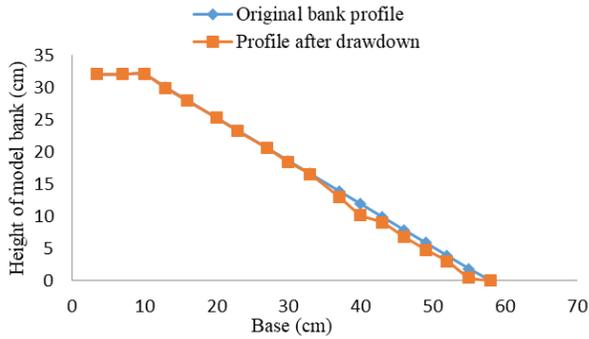
**Figure 6: Profile of bank for water content 13% and water level 50%**

One key takeaway from this experimental work was determining the failure location, failure time (Table 6). With water level 0.5 times of height, failure locations were found to be 20.92 cm and 11.4 cm from the bottom. Failures started to occur 27 and 32 seconds after the water recession, respectively, for 6% and 13% water content. These results go against the grain of traditional wisdom, implying that the start of bank failure is not always determined by the immediate aftermath of downturn. One important aspect affecting the temporal dynamics of bank stability is the pore water's outflow. Upon closer inspection, failures were evident at 28.72 cm and 21.9 cm from the bottom at an 80% H dip. For moisture concentrations of 6% and 13%, the commencement times were 26 and 37-seconds following drawdown started respectively. This illustrates the strong relationship between water content, drawdown height on stability of bank. The findings presented in this study enhance our comprehension of the complex temporal and spatial variations that govern the stability of riverbanks during drawdown. The expulsion of pore pressure also an important parameter to impact the stability.

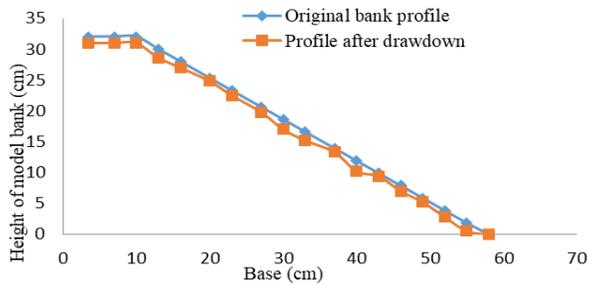
**Figure 7: Profile of bank for water content 13% and water level 80%**

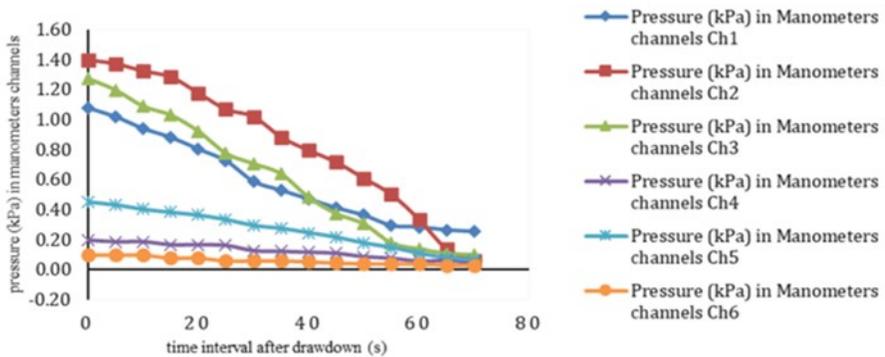
**Figure 8: Pore Water Pressure distribution of model bank in 13 % moisture content at drawdown ratio 80% H**

The sand used in the construction of the model bank had varying levels of moisture content, specifically 6% and 13%, and a slope of 1H:1.5V. The tank containing the model bank was then filled with water to two different heights, specifically 50%H and 80%H. The results of the experiment indicate that during the initial stage of drawdown, the pore water pressures in channels Ch1, Ch2, and Ch3 were measured to be 1.08, 1.40, and 1.27 kPa, respectively, for a moisture content of 13% and a water level at 80%H. In contrast, the upper channels, namely Ch4, Ch5, and Ch6, exhibited significantly lower pore water pressures, measured at 0.2, 0.45, and 0.10, respectively. These findings can be further examined in Figs. 8 and 9.

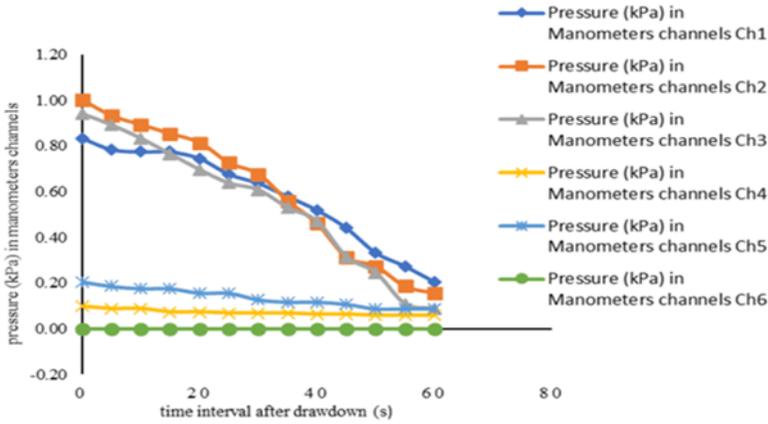
**Figure 9: Pore Water Pressure distribution of model bank in 13 % moisture content at drawdown ratio 50% H**

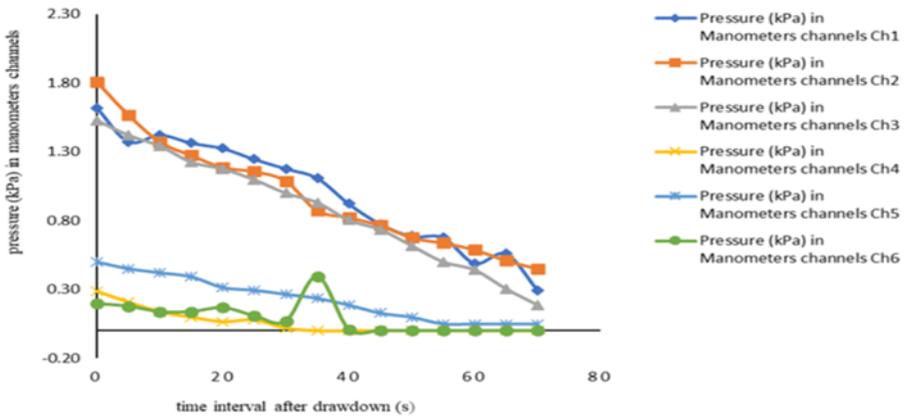
**Figure 10: Pore Water Pressure distribution of model bank in 6.0% moisture content at drawdown ratio 80% H**

For a water content of 6% and a drawdown of 0.8H, the initial manometer readings were documented as 1.62, 1.81, 1.53, 0.28, 0.5, and 0.20 kPa for channels 1, 2, 3, 4, 5, and 6, respectively. These results of pore water pressure indicate that the combination of 6% moisture content and 80 % H drawdown generates a more precarious state for the slope. The bank displayed increased vulnerability to failure under the drawdown of 80 % H with a moisture content of 6%. As time progressed, the dissipation of pore water took place, and after 50 seconds, it was observed that the rate of dissipation was quicker in the model bank with 13% moisture content and 80%H drawdown compared to other scenarios, as illustrated in Figs. 10 and 11.

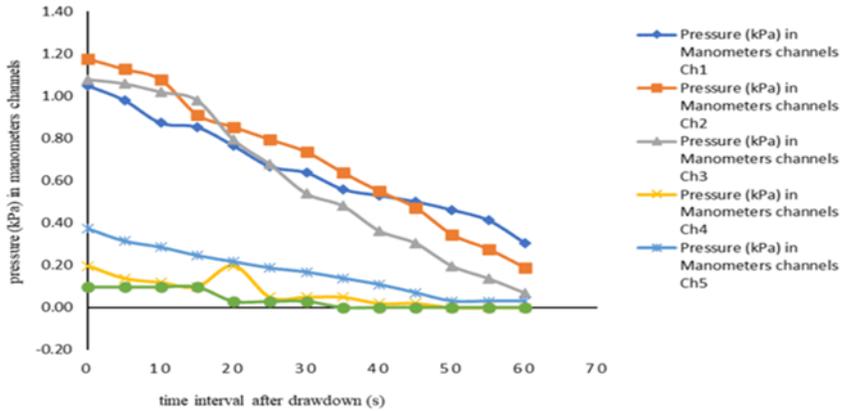
**Figure 11: Pore Water Pressure distribution of model bank in 6% moisture content at drawdown ratio 50% H**

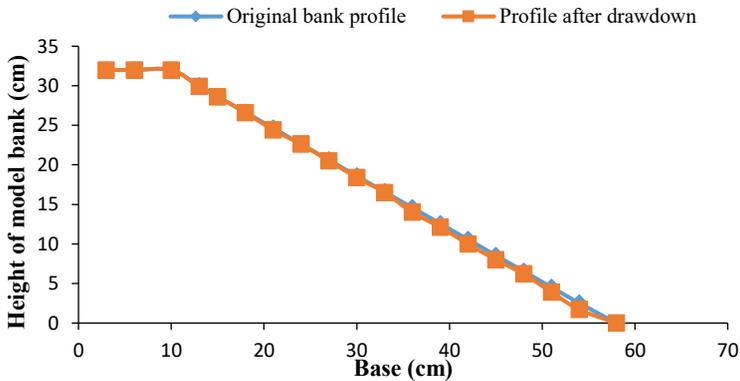
**Figure 12: Profile bank for water content 10% and water level 80%**

As seen in Figs. 12, 13 and 14, partial erosion and the development of a longitudinal fracture happened at 0.8 times of height of flow. Furthermore, as Table 7 shows, it was found that the failure position for an 0.8 times height of drawdown began 16 and 21 cm from the bottom at intervals of 46 and 61 seconds, respectively. The properties of the silty clay soil have affected these observations significantly. Because the internal cohesive action of the bank material efficiently withstands the seepage pressures working on the bank during water outflow following drawdown, the forces causing bank failure have less of an impact on erosion and failure in silty dominated clay. The findings indicate that the sand-based bank exhibits a somewhat similar failure to what was seen on the field.

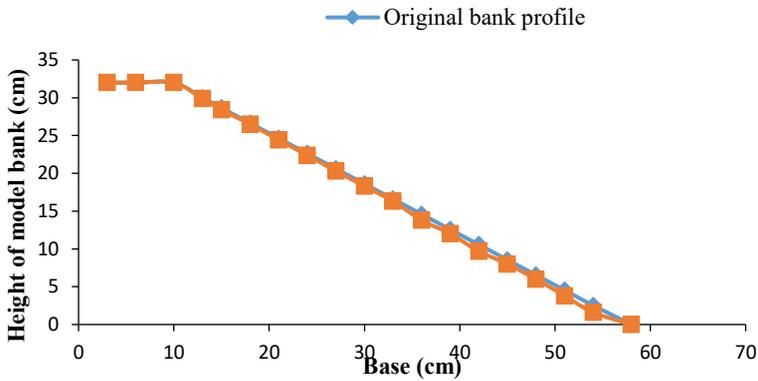
**Figure 13: Profile of bank for water content 15% and water level 80%**

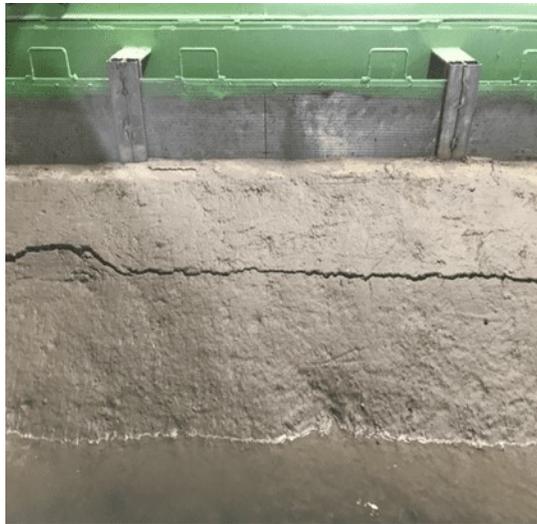
**Figure 14: Failure crack**

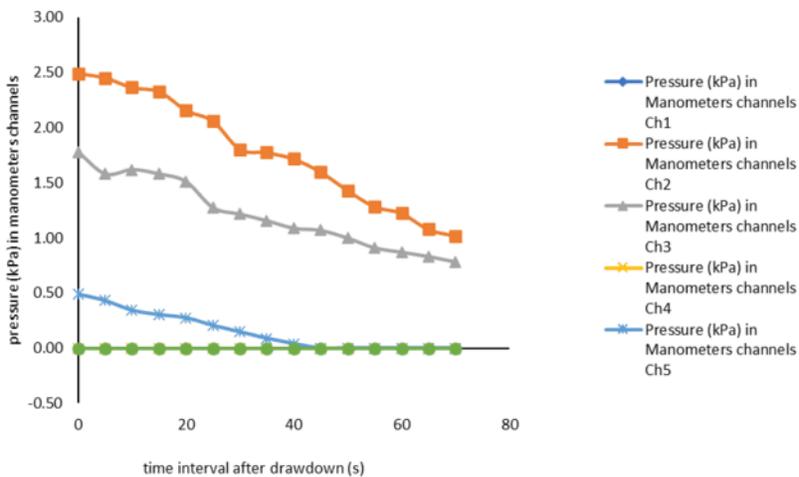
**Figure 15: Pore Water Pressure distribution of model bank in 15.00% moisture content at drawdown ratio 80% H**

In the second set of experimental trials, a replica river bank was fabricated employing silty clay soil. The field density was simulated by maintaining the moisture content of the replica river bank at 10% and 15%, corresponding to 15.6 and 16.85 kN/m<sup>3</sup>, respectively. The drawdown ratio remained consistent with the previous experiments. It was observed that the pore water pressure in silty clay differed from that in banks made of sandy soil. For a moisture content of 15% and drawdown of 80%H and 50%H, channels such as Ch1 and Ch4 displayed minimal manometer readings, indicating the absence of pore water in the deeper section of the bank. Conversely, channels closer to the surface, such as Ch2, Ch3, and Ch5, exhibited significantly higher pore water pressures, measuring 2.49, 1.78, and 0.49 kPa, respectively (refer to Figs. 15 and 16). Furthermore, it was noted that pore water pressure did not dissipate easily from the replica bank. Measurements taken 50 seconds after drawdown showed only a 40% to 50% reduction in pore water pressure, which contradicted the quicker dissipation observed in the replica bank constructed with sandy soil in previous experiments.

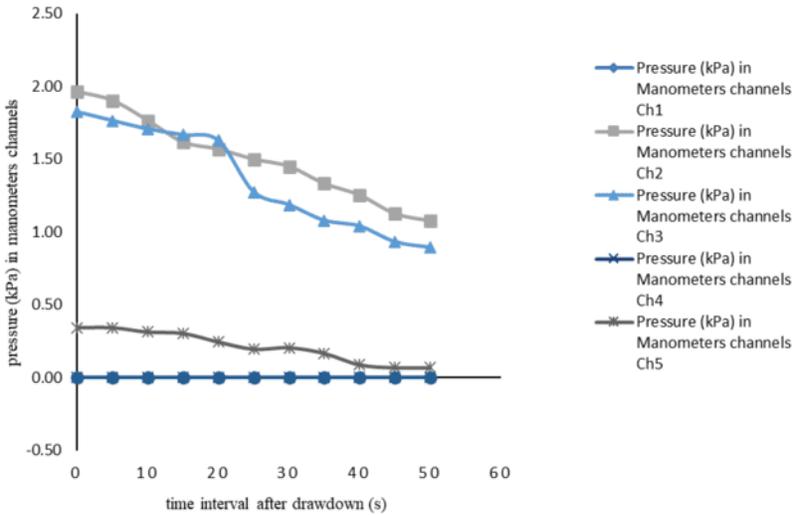
**Figure 16: Pore Water Pressure distribution of model bank in 15.00% moisture content at drawdown ratio 50% H**

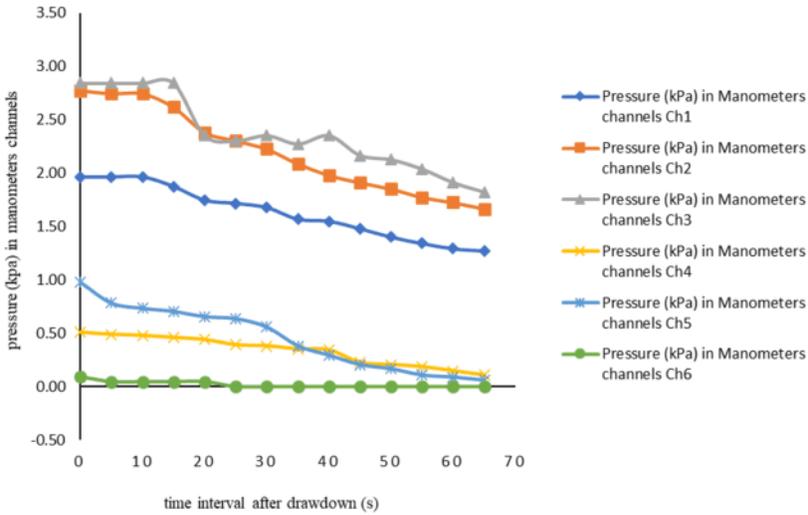
**Figure 17: Pore Water Pressure distribution of model bank in 10.00% moisture content at drawdown ratio 80%H**

Significantly high pore pressure was observed in Channels Ch2 and Ch3, with pressure readings of 2.78 and 2.84 kPa, respectively, for model banks containing 10% moisture content under both drawdown conditions (80%H and 50%H) (Figs. 17 and 18). In contrast, Channels Ch1, Ch4, Ch5, and Ch6 displayed lower pressures of 1.96, 0.54, 0.98, and 0.10 kPa, respectively. However, even after 50 seconds from the drawdown, only a portion of the pressure, ranging from 30% to 40%, dissipated. These results indicate that a moisture content of 10% retains more pore water pressure compared to a moisture content of 15%. Additionally, the dissipation of pressure was slow for both moisture contents. These findings suggest that the river bank, composed of silty clay, exhibited less failure compared to the sandy soil model bank. This can be attributed to the cohesive nature of the silty clay, which plays a crucial role in impeding failure.

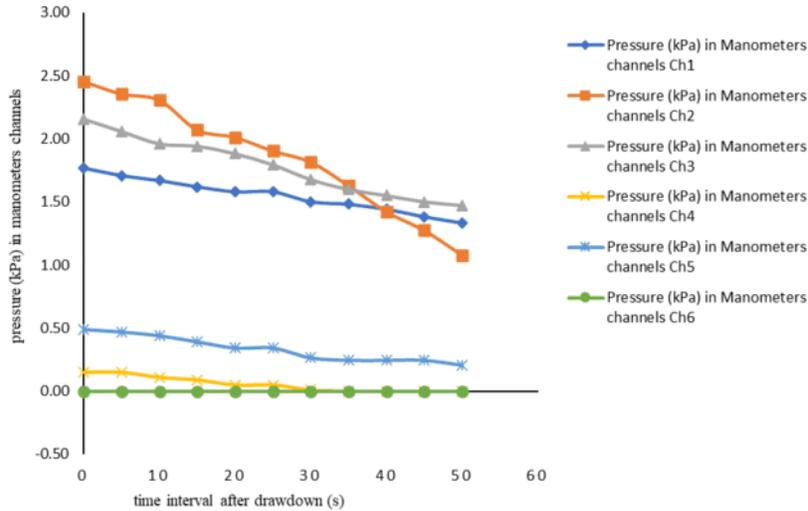
**Figure 18: Pore Water Pressure distribution of model bank in 10.00% moisture content at drawdown ratio 50%H**
